# Hard Times Or Promising Future For Composting In Mexico?

In the past, MSW composting facilities have failed due to lack of planning, technical support and inadequate regulations. A new technical approach is needed to recycle the great amount of organics in the waste stream.

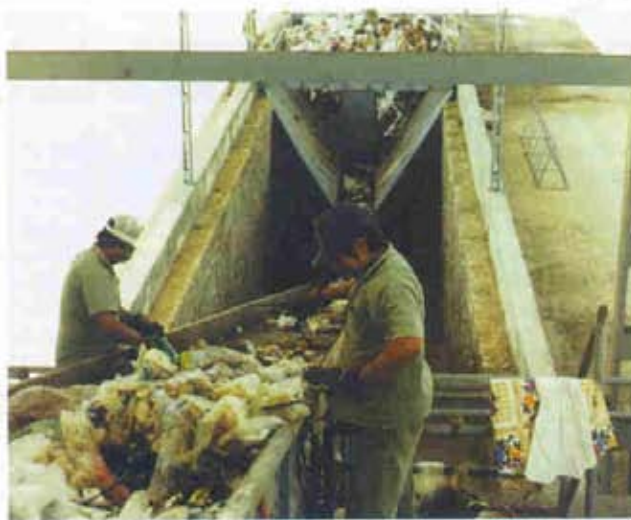
The inability to remove all contaminants from incoming feedstocks resulted in low quality composted products.

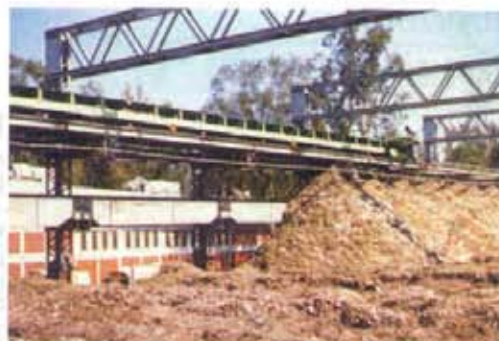
**Inadequate technology selection has been identified as a major cause for past failure of large-scale MSW composting projects in Mexico.**
